[Docket No. 2001-NE-03-AD; Amendment 39-12097; AD 2001-02-12]

Airworthiness Directives; CFM International (CFMI) model CFM56-7B Turbofan Engines

ACTION: Final rule; request for comments.

2001-02-12 CFM International: Amendment 39-12097. Docket No. 2001-NE-03-AD.

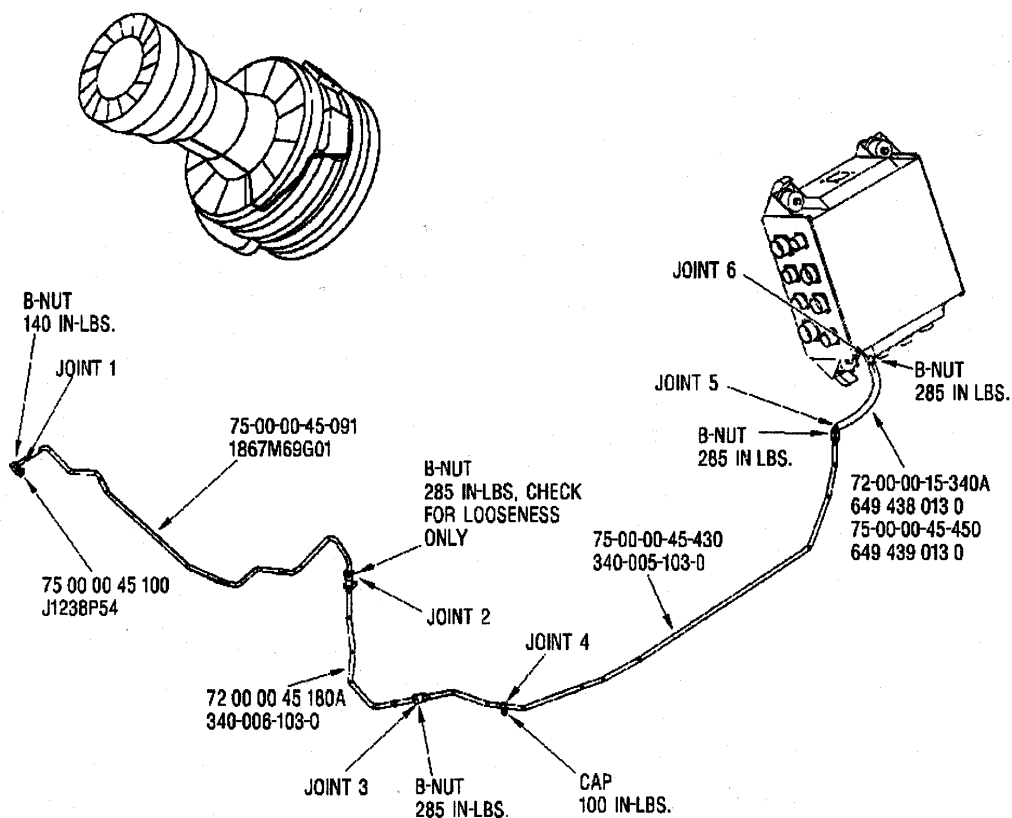
Figure 1. Torque Values for PS3 Line Fittings

SUPPLEMENTARY INFORMATION: The FAA has received reports of two in-flight shutdowns and one aborted take-off on three different Boeing 737NG airplanes powered by CFM56-7B turbofan engines. In all of these cases, the engine rolled back to idle speed and would not accelerate. The investigation revealed that the PS3 pressure line B-nut fitting at the 6 o'clock position had disconnected in two of these events and the PS3 pressure B-nut fitting at the combustion case port location had disconnected in the third event. An operator, involved in one of the IFSD events, completed on-wing torque inspections of the PS3 pressure line fittings of its CFMI CFM56-7B fleet. As a result of these inspections, one engine was found with a loose B-nut fitting at the 6 o'clock location and two engines were found with loose cap fittings at the 6 o'clock location. The two engines with loose caps were on the same airplane. The investigation also initiated PS3 pressure line fitting torque inspections on 10 engines that were on Boeing's flight line. These inspections revealed one engine with a loose B-nut fitting at the 6 o'clock position and one engine with a loose cap fitting at the 6 o'clock position. General Electric and SNECMA also inspected CFM56-7B engines that were in assembly. No loose fittings were found. The investigation to determine the cause of the loose PS3 pressure line fittings continues. Action to insure correct torque of these fittings on current production engines has been initiated by adding a new torque inspection requirement for the PS3 pressure line fittings at the end of the main engine assembly process. However, based on the inspection results indicated above, it has been determined that mandating action on in-service engines to ensure that the PS3 pressure line fittings are correctly torqued is required.

To prevent air leakage from incorrectly torqued fittings of the PS3 pressure line, which could result in engine power loss, do the following:

(a) Check for and apply the correct torque in the tightening direction of all PS3 pressure line fittings as identified in Figure 1 of this AD as Joint 1, Joint 2, Joint 3, Joint 4, Joint 5, and Joint 6 as follows:

- (1) Torque Joint 1 to ensure a torque value of 140 inch-pounds.
- (2) Due to accessibility limitations, check Joint 2 for finger looseness, and only if loose, torque to a value of 285 inch-pounds.
- (3) Torque Joint 3, Joint 5, and Joint 6 to ensure a torque value of 285 inch-pounds.
- (4) Torque Joint 4 to ensure a torque value of 100 inch-pounds.
